Corrosion Resistance of Alternative Reinforcing Bars: An Accelerated Test

Final Report

24 July 2006

Wiss, Janney, Elstner Associates, Inc.

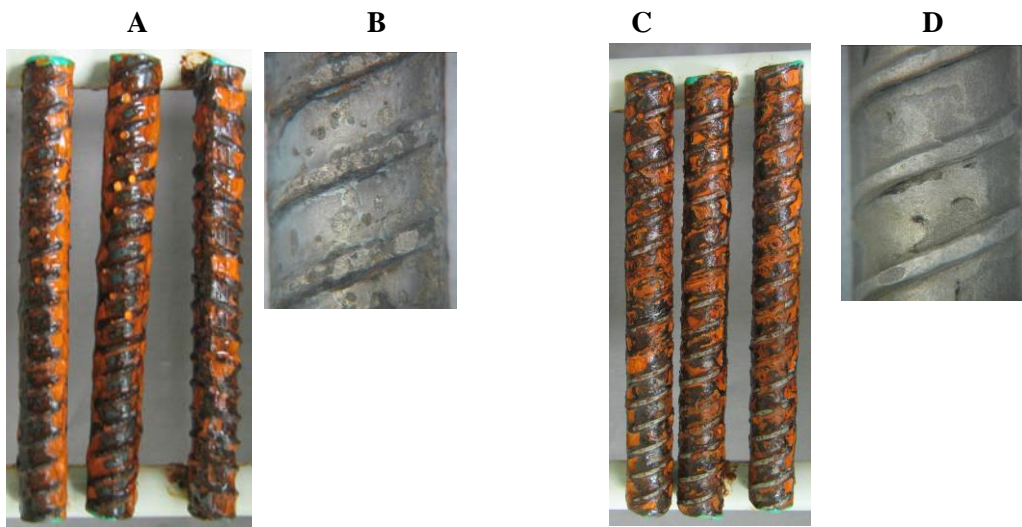
Both as-received and sandblasted bars corroded extensively and corrosion progressed quickly with time. Corrosion of as-received bars appeared to be more localized, probably due to the presence of the millscale

oxide layer. The averaged corrosion rate of the three bars exposed for up to 28 days was 914.7 $\mu\text{m}/\text{year}$. As shown in Figure 2, the sandblasted bars experienced rather uniform corrosion. Corrosion rates, however, were consistently higher than the as-received bars. The estimated average corrosion rate of metal loss was about 70% higher than the as-received bars. Figure 2 shows the appearance of the bars after 174 hours of exposure.

Figure 2. Appearance of A615 bars after 174 hours of exposure. A) as-received; B) as-received after cleaning; C) sandblasted; D) sandblasted after cleaning

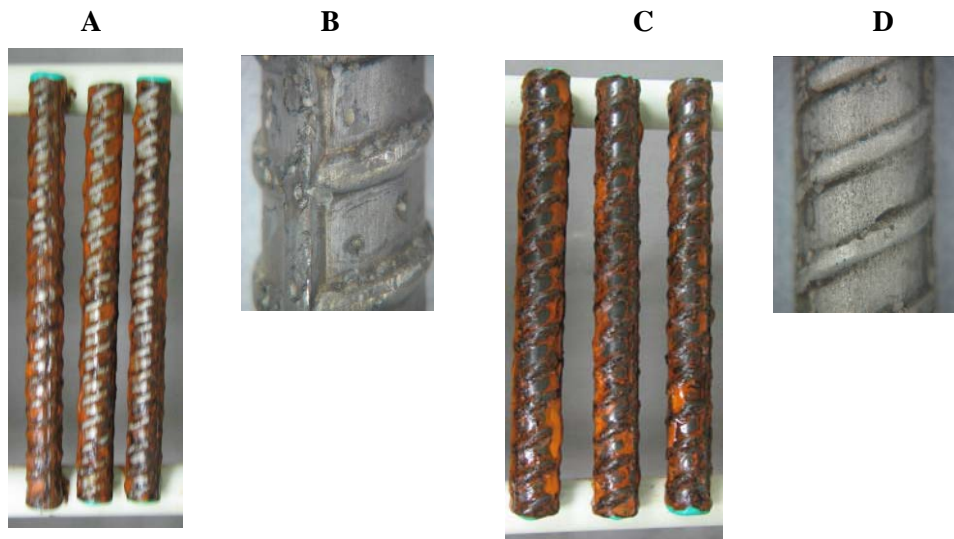
Both as-received and sandblasted bars corroded significantly and corrosion progressed quickly with time. In both conditions, as illustrated in Figure 3, corrosion often took the form of deep pitting. Some pits had depths as high as 1 mm (measured with micrometer, one was 1mm and many were in the order of 0.5mm) after 440 hours of exposure. The average corrosion rate of metal loss were 625 and 523.6 $\mu\text{m}/\text{year}$ for as received and sandblasted bars, respectively, which are about 60 percent of that of as received A615 bars.

Figure 3. Appearance of A1035 bars after 174 hours of exposure. A) as-received; B) as-received after cleaning; C) sandblasted; D) sandblasted after cleaning

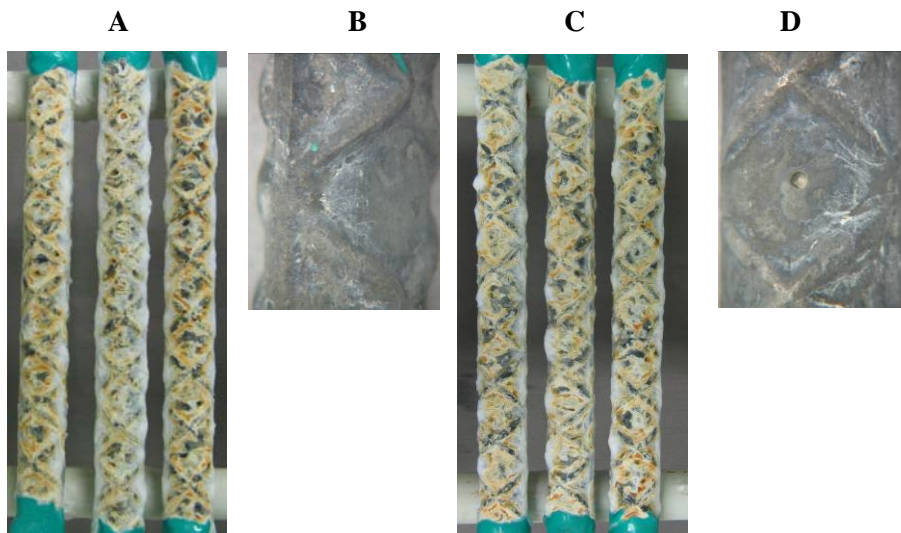
Galvanized bars with two different types of deformations were tested. All galvanized bars experienced extensive corrosion of a similar pattern: the zinc (Zn) coating corroded first producing a white color corrosion product and then the underlying carbon steel started to corrode producing a rusty color. Rust color was prominent after 2 weeks of exposure. The exposed carbon steel at drilled holes was protected until the adjacent zinc coating was consumed.

Weight loss analysis showed that these galvanized bars experienced extensive corrosion with very high corrosion rates. Average corrosion weight loss of the undamaged (Type A) galvanized bars, for example, was 1330 $\mu\text{m}/\text{year}$ which is about 30 percent higher than that of the as-received A615 bars. Figure 4 shows the appearance of the Type A galvanized bars after 174 hours of exposure. Photos of pre-damaged (Type B) bars are documented in the appendix.

Figure 4. Appearance of Type A galvanized bars after 174 hours of exposure. A) no hole; B) no hole after cleaning; C) with a hole; D) with a hole after cleaning

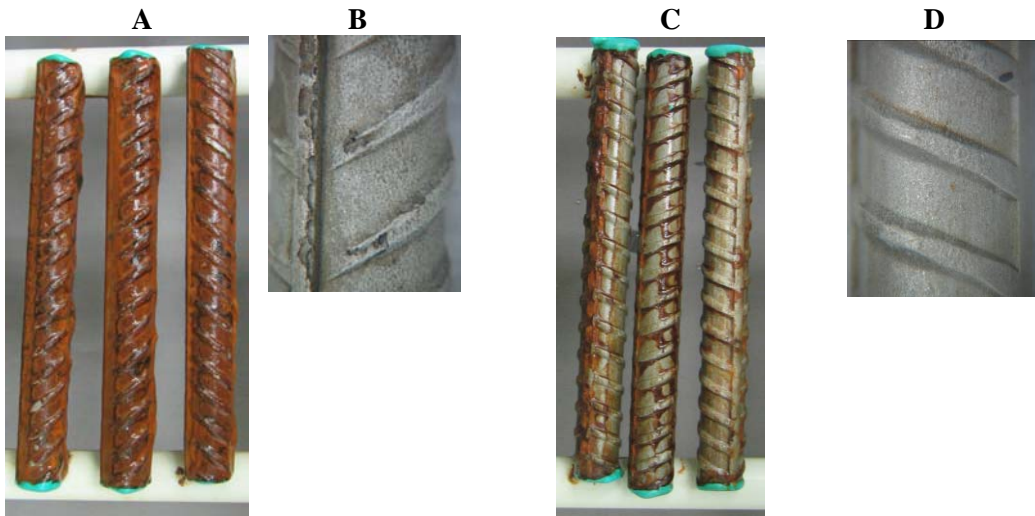
Soon after exposure started, as shown in Figure 5, surfaces of the sandblasted bars assumed a largely uniformly rusty color. After cleaning, it was observed that the bars experienced general corrosion attack at most areas and also some deep pitting corrosion near ribs. While corrosion of 3Cr12 appeared to be extensive, its average corrosion was just $\sim 300 \mu\text{m}/\text{year}$, half of the A1035 and about 1/3 the rate of the as-received A615 steel bars.

After 12 hours of exposure, as shown in Figure 5, corrosion products were visible on most of the bar surfaces and corrosion progressed with time. However, the cleaned bar showed that corrosion was rather superficial and no obvious pits were observed. Weight loss analysis yielded a very low average corrosion of 29.7 $\mu\text{m}/\text{year}$, which is about 3% of as-received A615 bars.

Figure 5. Appearance of stainless steel 3Cr12 and 2201 after 174 hours of exposure. a) 3Cr12; b) 3Cr12 after cleaning; c) 2201; d) 2201 after cleaning

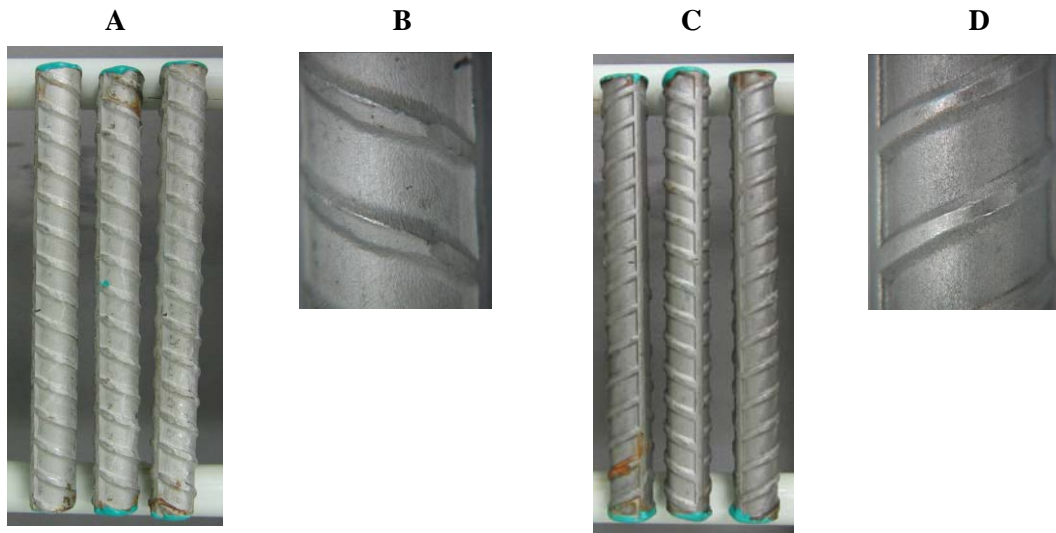
Both types of stainless steels experienced some very localized corrosion and such corrosion evidently progressed with time. However, the total amount of corrosion was trivial and such corrosion was

speculated to have been induced by local contamination or crevices generated by the coating used to seal cut ends. The estimated corrosion rates were lower than 2 $\mu\text{m}/\text{year}$ for both materials. Surface condition of these bars after 174 hours of exposure is shown in Figure 6.

Figure 6. Appearance of stainless steel 316LN and 2205 after 174 hours of exposure. A) 316LN; B) 316LN after cleaning; C) 2205; D) 2205 after cleaning

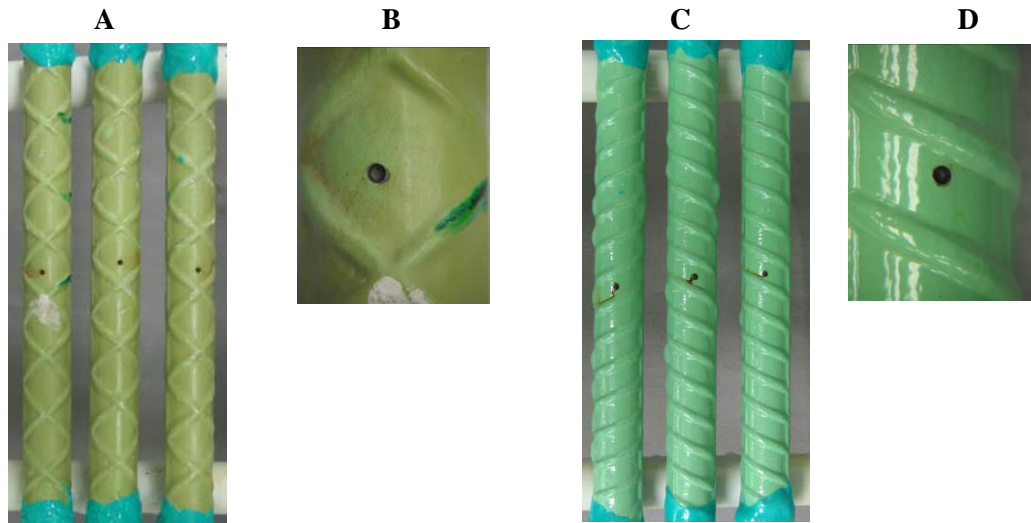
These epoxy-coated bars were recently produced and initially had no holidays. Specimens tested in the as-received condition experienced no corrosion throughout the 28-day testing program. The specimens with a drilled hole only corroded at the holes.

ECR bars (type B) were extracted from a 15-year-old bridge deck in Chicago area, and these bars also performed very well in this testing program. For the first 174 hours of exposure, corrosion only took place at the drilled holes where underlying carbon steel was exposed. At time 440 hours, corrosion at additional sites (one location on each of the two remaining bars) was observed which apparently took place at pre-existing coating defects (one at a smashed area and one at a holiday).

For all the ECR specimens, corrosion only took place at coating defects such as drilled holes. Likely due to moisture absorption by the epoxy coating, weight loss measurement often yielded negative values. Accurate corrosion rates of these specimens consequently were not obtained. Corrosion of these specimens was nevertheless very localized and mass loss appeared to be trivial when comparing to that of uncoated A615 bars.

Figure 7. Appearance of ECR after 174 hours of exposure. A) ECR-Type B-hole (15 years old extracted from a Chicago bridge deck); B) ECR-Type B-hole, after cleaning; C) ECR-Type A-hole; D) ECR-Type A-hole, after cleaning

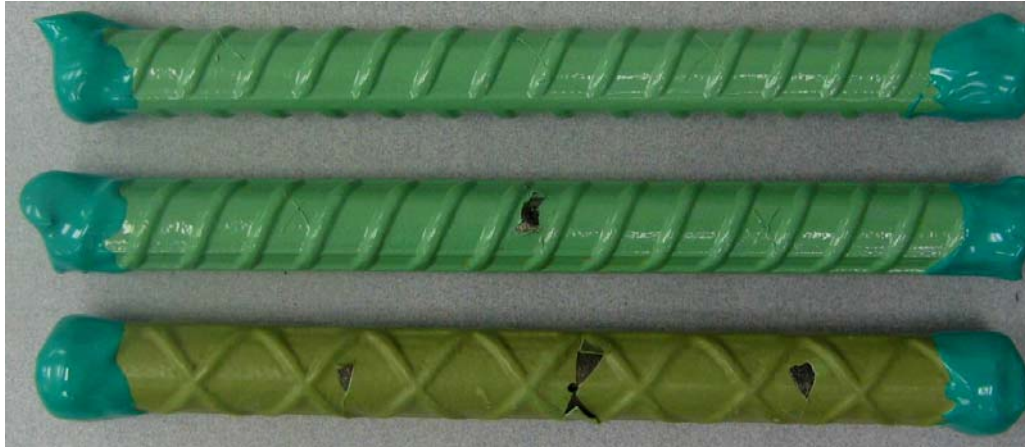
Table A2 summarizes the adhesion of the epoxy coating before and after being tested in the salt-spray chamber for up to 4 weeks. The recently coated bars (ECR-Type A) only lost some adhesion (1 to 1.5 points) at the drilled holes while the coating remained well bonded to the steel away from the drill holes. Likewise, the bars (ECR-Type B) extracted from the Chicago deck showed some adhesion loss at drilled holes (about 1.5 points) while adhesion at areas away from the holes remained largely unchanged. Figure 9 shows the knife adhesion results of three epoxy-coated bars after up to 4 weeks of exposure. All the three bars removed from the deck, including the two that had low adhesion before exposure, were largely corrosion-free except for localized corrosion at existing defects.

Figure 9. Knife adhesion test of Epoxy-coated bars after 4 weeks of exposure. From top to bottom: ECR-Type A-no hole; ECR-Type A-hole; ECR-Type B-hole

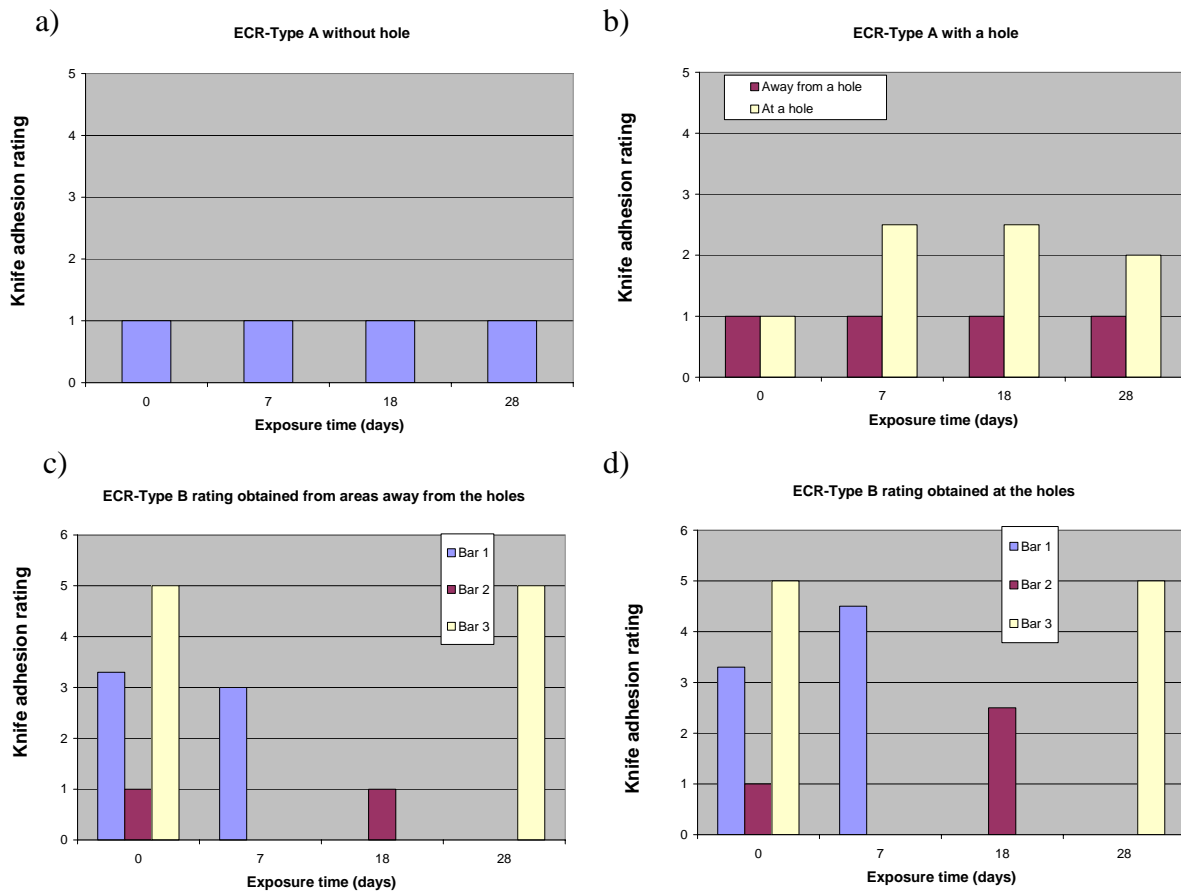
While chloride concentrations at the bar depth in the 15-year old Chicago bridge deck were higher than the threshold for black steel, no corrosion was observed on any of extracted bars and no distress was detected in the deck. As shown in Figure 10, the extracted bars had coating adhesion from very good (1) to poor (5). In addition, the bars with poor adhesion (5) remained passive in this highly accelerated testing program. These observations attest that adhesion loss does not necessarily indicate loss of protection.

Figure 10. Knife adhesion rating of epoxy-coated bars

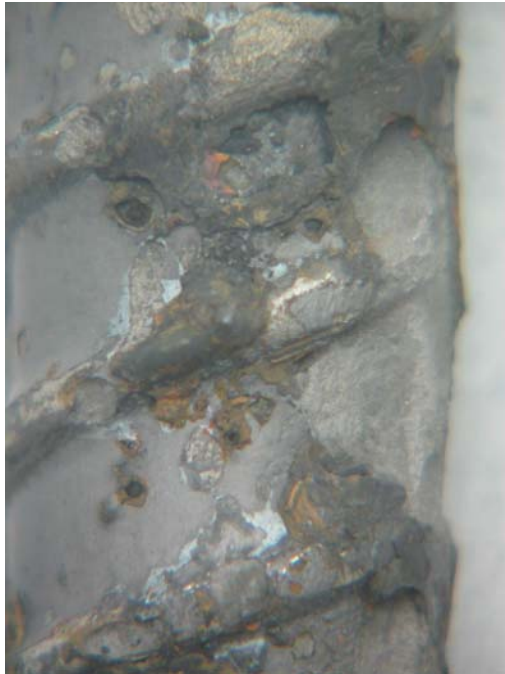
As received
A615 bar:
extensive
corrosion, many
broad pits

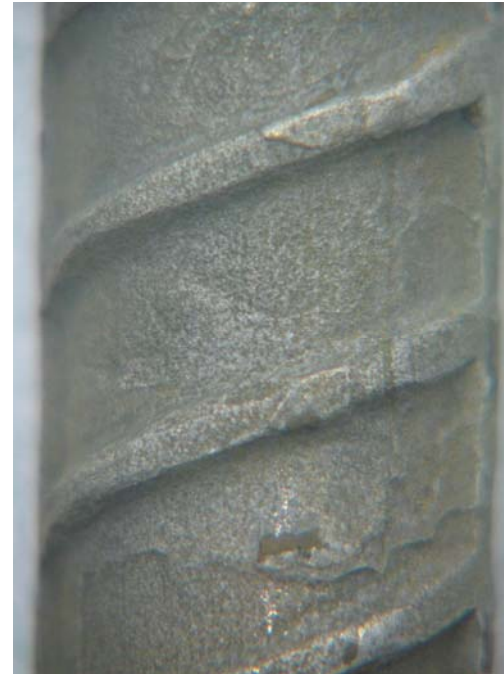
Sandblasted
A615 bar:
extensive
corrosion,
more uniform

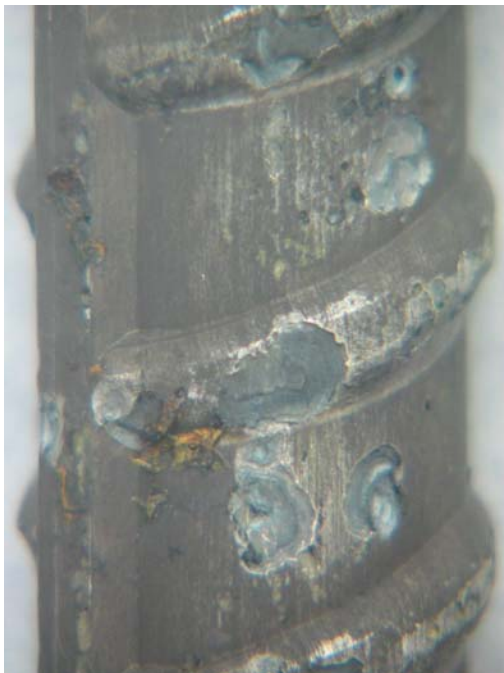
As received
A1035: deep
pits

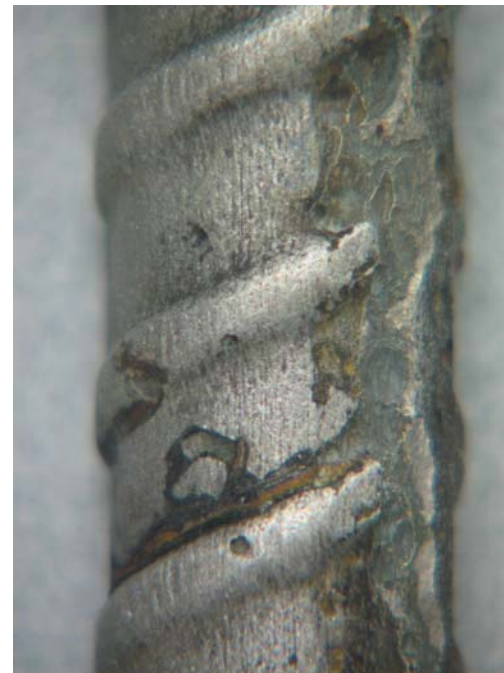
Sandblasted
A1035: broader
pitting attack

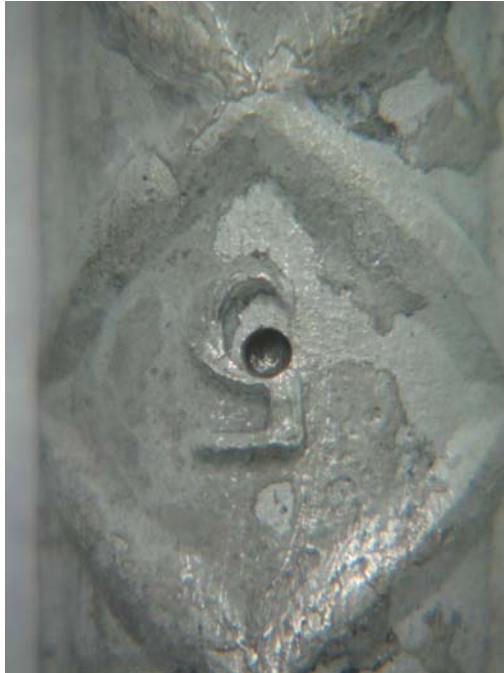
Galvanized-type A:
extensive corrosion, many parts lost Zn coating. Steel in hole was largely protected

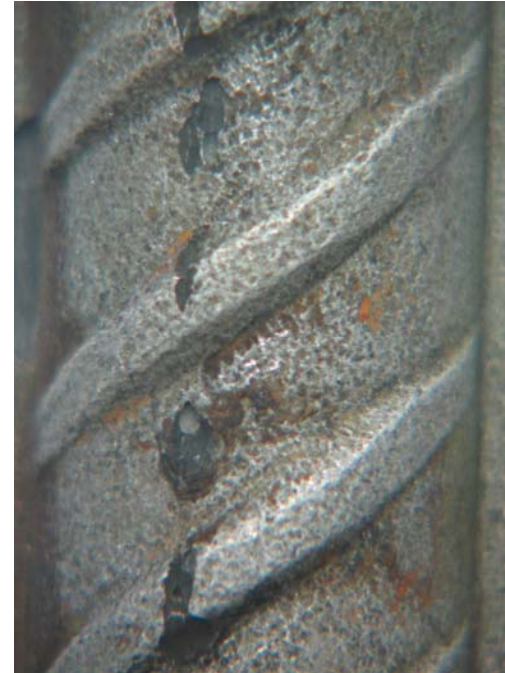
Sandblasted 3Cr12:
extensive corrosion, pits and general

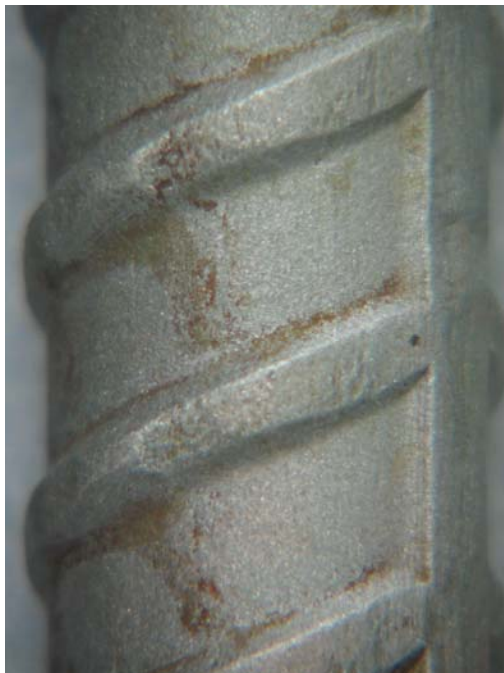
Sandblasted 2201:
widespread superficial corrosion

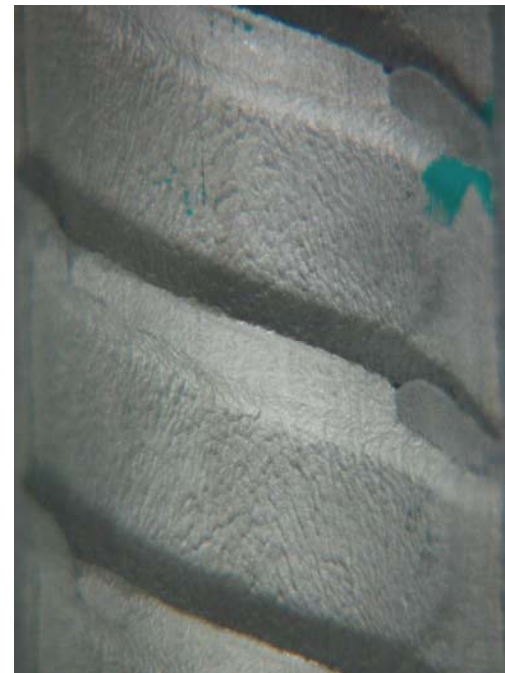
As received 316LN: pristine condition except minor corrosion at bar ends

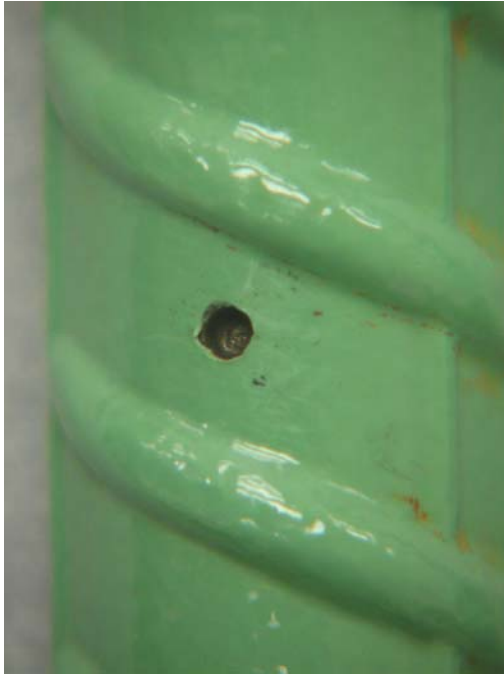
ECR-Type A:
only steel
exposed at the
drilled hole
corroded

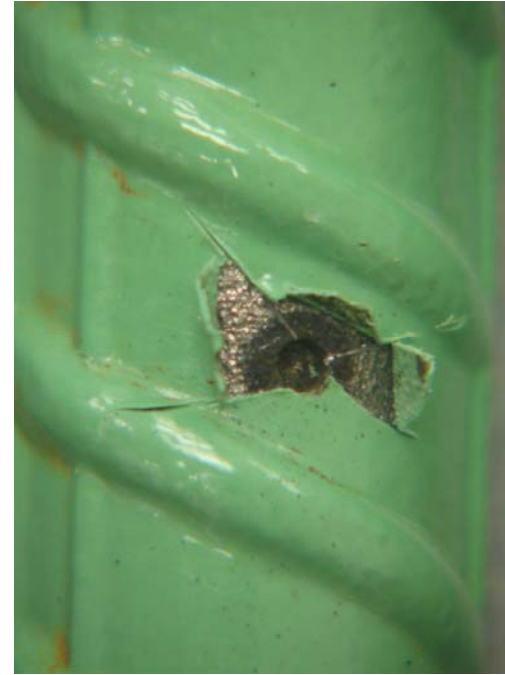
ECR-Type A-
adhesion: dark
area lost
adhesion, rate-
2.5

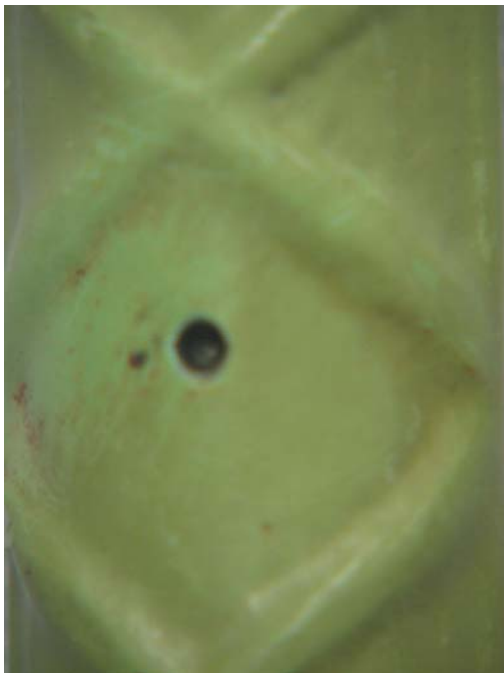
ECR-Type B:
Only steel
exposed at the
drilled hole and
a pre-existing
defect corroded

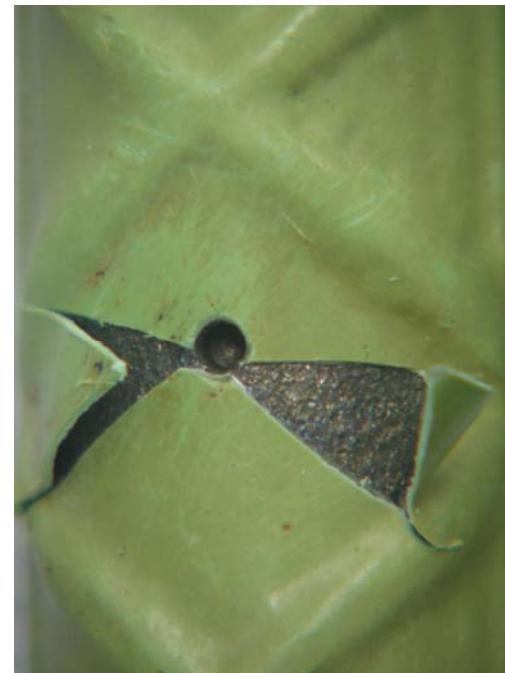
ECR-Type B-
adhesion:
coating easy to
peel: rate-5
