Tangier Island Bridge

Tangier, Virginia

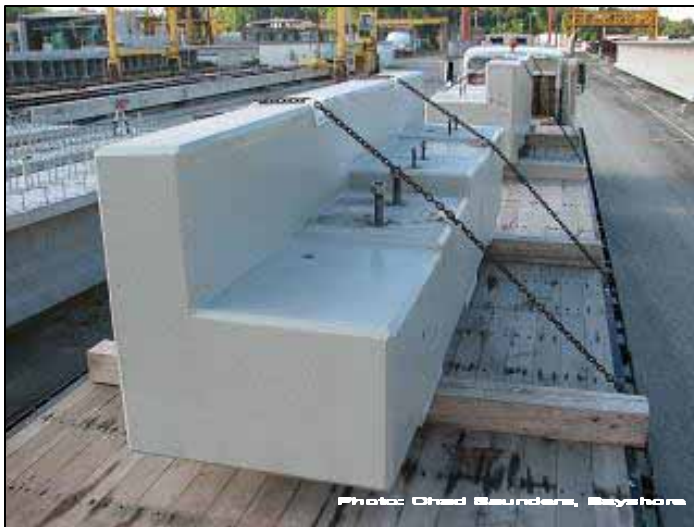
Precast abutments shipped from Bayshore facility to Tangier Island.

By precasting the abutments, the contractor was able to ship the bridge components by barge to Tangier Island and place them into position, without incurring the costs of on site cast-in-place construction. From beginning to end the entire prefabrication job took 14 days. A purchase order was received on April 11 and the welded cages were on a truck and for delivery to Bayshore by April 25, 2006.
